A Second & Serious V12 'E' Type Petrol Leak and Fixing Procedure

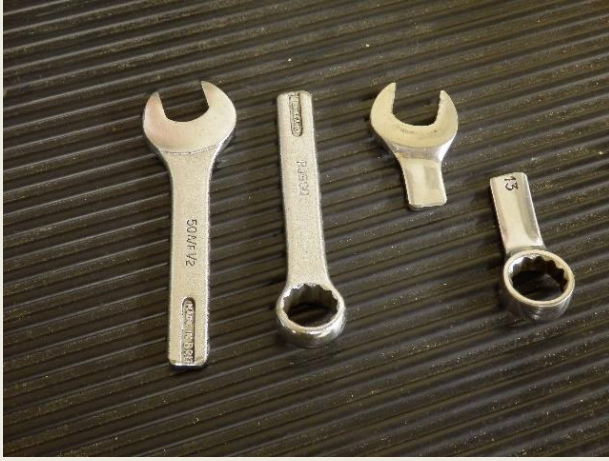
Carburettor Removal - Reqd. Cut Down Spanners

A strip down of linkages, pipework, air cleaner box and the main petrol feed was therefore essential and proceeded with invaluable help from my son Ashley, who handed spanners and other tools to me to speed up the operation. The carburettor itself was not an easy removal, as one of the bottom retaining nuts is almost completely inaccessible and no spanner could shift it. However and by chance, an RAC patrol was fixing a car opposite my home and a call for assistance was happily answered. He too found the same problem, but not deterred cut one of his spanners in half to fit into the restricted area and with this successfully achieved the near impossible. His help clearly reinforced the value of being an RAC member and on leaving he donated the two spanner halves to me, to ensure that I would have no further difficulties. A cold drink for him on a hot day being the only cost - good old RAC!! A useful suggestion at this point, when taking so much apart, try to put an old towel in place under the work area to catch that elusive nut or bolt, which will inevitably escape the fingers and then find its way into an inaccessible corner. It certainly saved me on a series of occasions!!

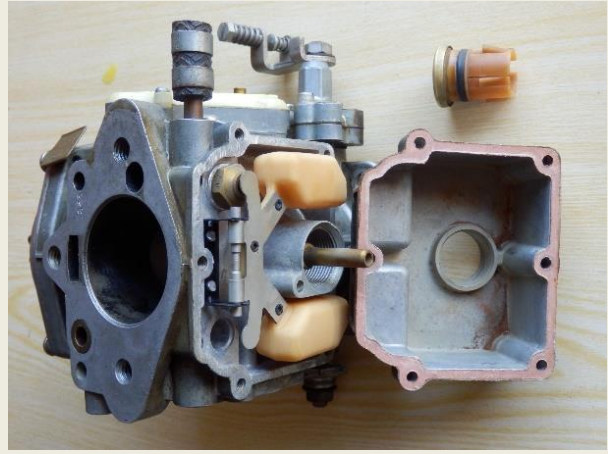
With the one carburettor removed, it was then clear that the problem was located in the underside of the float chamber, which was awash with fuel. Dismantling soon found that the bottom sealing plug was spinning loose due to failure of the internal rubber sealing "O" ring, which had flattened and hardened. A call to my local Jaguar Distributor found, on this occasion, that this small and essential part is no longer listed by Jaguar, but once again my friendly man at S N G Barratt came to the rescue, with new parts delivered overnight, so not delaying the repair. With one faulty float chamber and so much dismantled, it was clear that both nearside Strombergs needed to be removed for a similar repair, which then followed. Later all four carburettors will have to receive the same treatment, as the likelihood is that all will subsequently suffer the same problem.

Carb. and Failed Float Chamber Base Plug

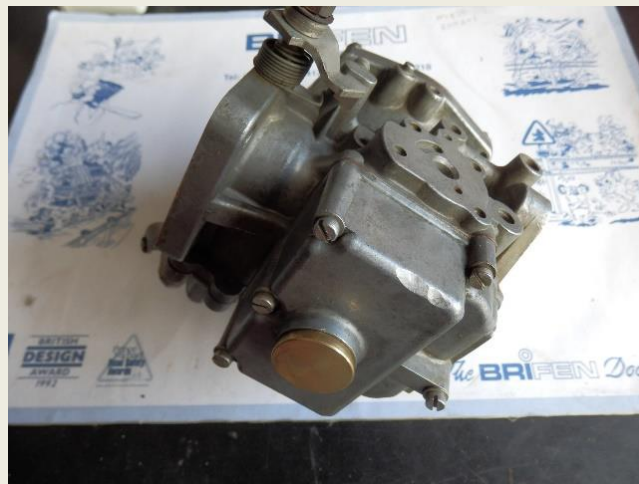
During reattachment of the float chamber bottom alloy casting, it was noticed that there was a fretted area on the external edge of the float chamber, which had extended to about half the casting thickness. This had arisen from the steel braided petrol return hose over the years touching and abrading the float chamber base. This was corrected by re-angling the braided pipe, but is another area that I suggest is inspected by all V12 'E' Type drivers, as over time this could wear a hole through the float chamber base.

Base of Float Chamber Fretted by Steel Braided Petrol Return Pipe
