## Part 5

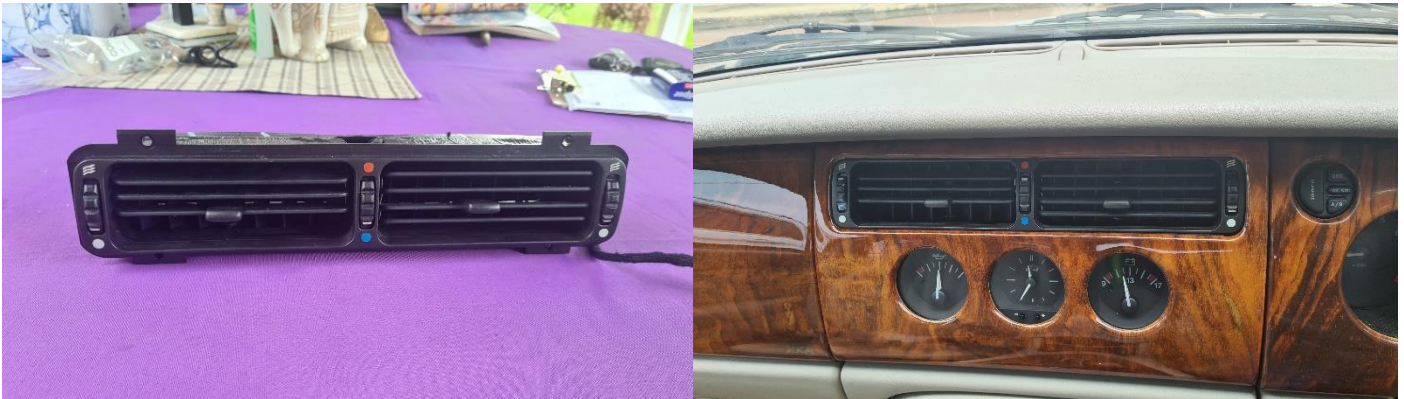
Another thing I couldn't "unsee" was the centre air vents. The vanes had all broken away from their mountings, resulting in me being unable to direct the air – inconvenient, and very unsightly! Apparently though, it's a recognised fault/occurrence in this model, and Ross had exactly the same problem in his convertible.

covered just this fix in two parts on his channel. The repair is fiddly but very do-able so I decided to give it a go, and the bonus was it involved a bit of plastic welding, something I've always wanted to try. I started with Ross' car, and the two of us spent a happy couple of hours fiddling around – with very acceptable success. Having experimented(?) on another car, I set about doing the repair on my own, only to find that I was actually missing one vane! Anyway, the repair can be declared a success, and I'm more than happy with the outcome. You can follow this link to the repair if you're interested – it should apply equally to other vehicles as well: [Vents part 1. Removing the air vents from your Jaguar XK8, XKR, X100 - YouTube](#)

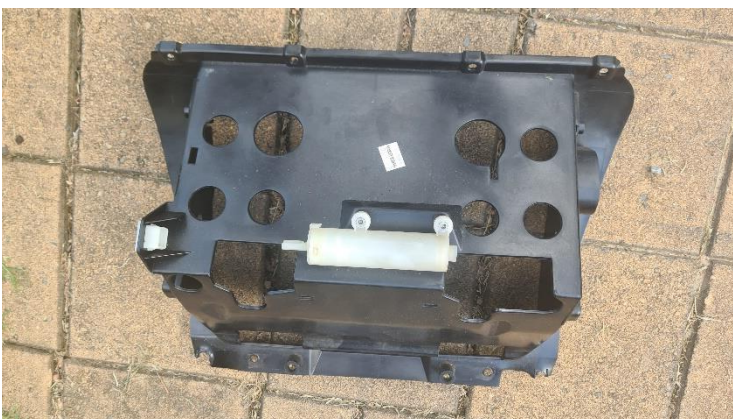
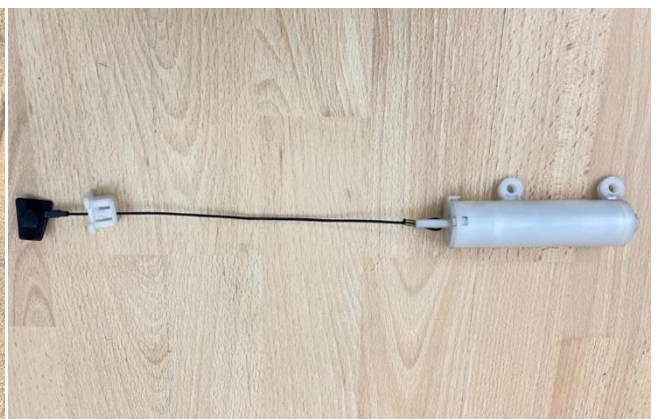
The lid shuts by means of two spring-loaded plastic shafts on either side that engage in two holes in the frame, holding the lid squarely shut – but my left hand bar wasn't springing out, so the lid would only shut on one side, leaving the other side to droop.

I managed to remove the lid and dismantle the spring mechanism. All it needed was a bit of cleaning and lubrication, and it now works exactly as it was designed to do, with no fear of not shutting properly. However, I went further and took out the glovebox liner – because I was in there anyway – only to find that my soft-open piston, which I didn't even know that I had, was not connected to the lid, so it just opened with a bang. The cord was missing! so I put everything back together and started my internet search. No luck finding just a cord, but I did eventually find a

piston complete with the cord, escutcheon and fixing button for a reasonable price, so a couple of weeks later I went

through the dismantling process again. I'm just happy to report that now, not only do I have a glovebox that closes correctly, it also opens slowly and gracefully – as befits a car of this class.....

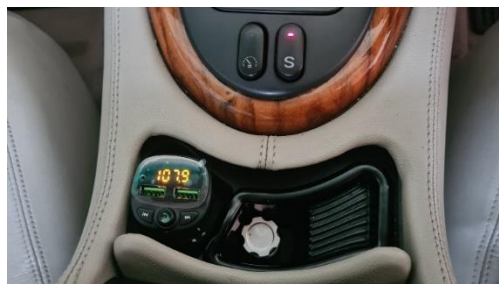
Last for this month, but not least, the XK100 head unit – the radio/CD console to some of us – does not have Bluetooth facility so you have to rely on your CD stack in the boot, or the radio. There are a few different options for fixing this while still retaining the original equipment, and I opted for the unit you can see on the left. It slots neatly into the cigar lighter (nothing so vulgar as a *cigarette* lighter in a Jag!), connects to your phone via Bluetooth, and transmits that to one of several FM channels of your choice.

You then pick up Spotify or your saved music, on the radio unit by tuning into the correct wavelength, in my case 107.9MHz. And it gives you hands-free phone access. The result, at least in my case, is reasonably acceptable, and I'm happy I can now sing along enthusiastically with Meatloaf while cruising up the highway. It's not the best, however, but I'll reserve judgement until I can fit some new speakers all round. Something for another day perhaps.
